Advisory Mission to Ukraine “Solotvyno salt mine area”

RISK ASSESSMENT REPORT

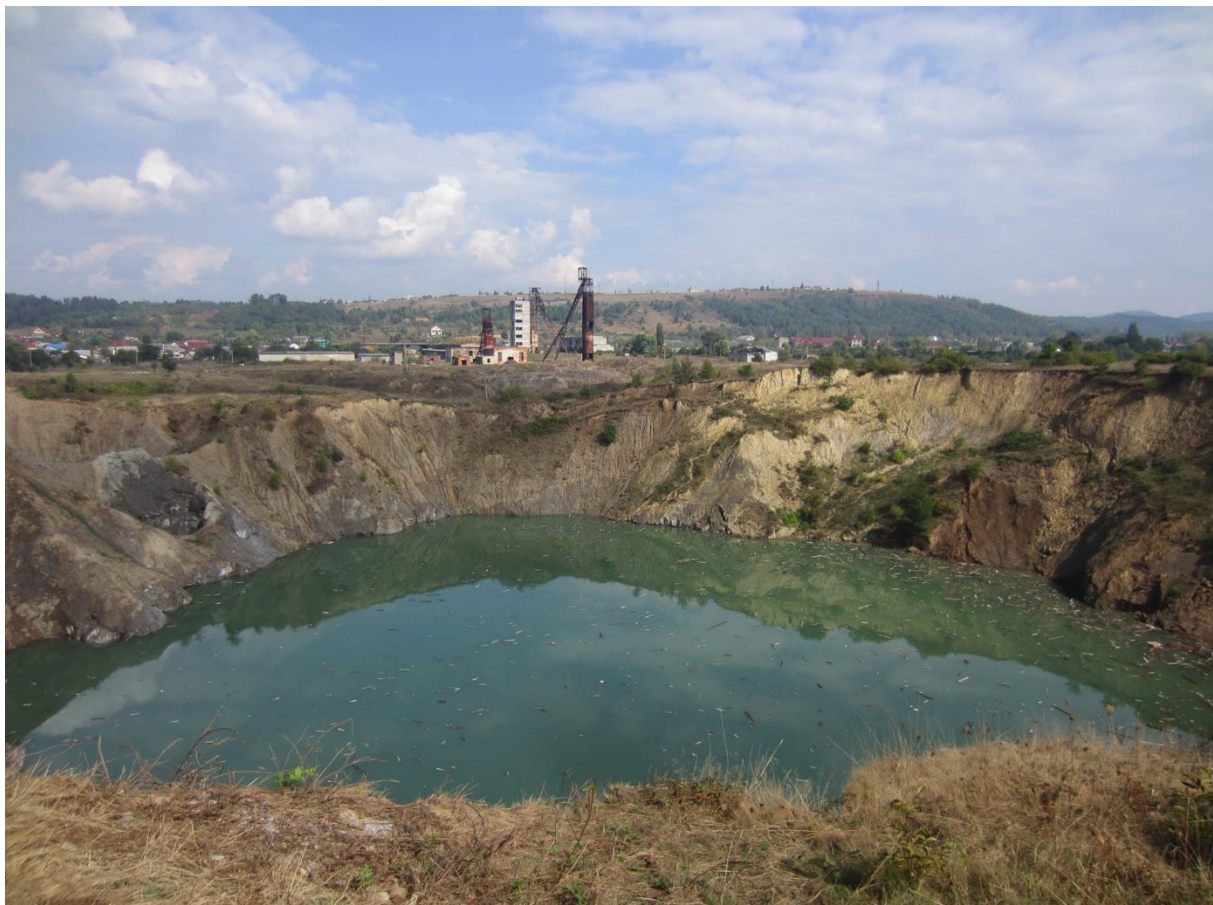
Figure: Crater Mine No 7

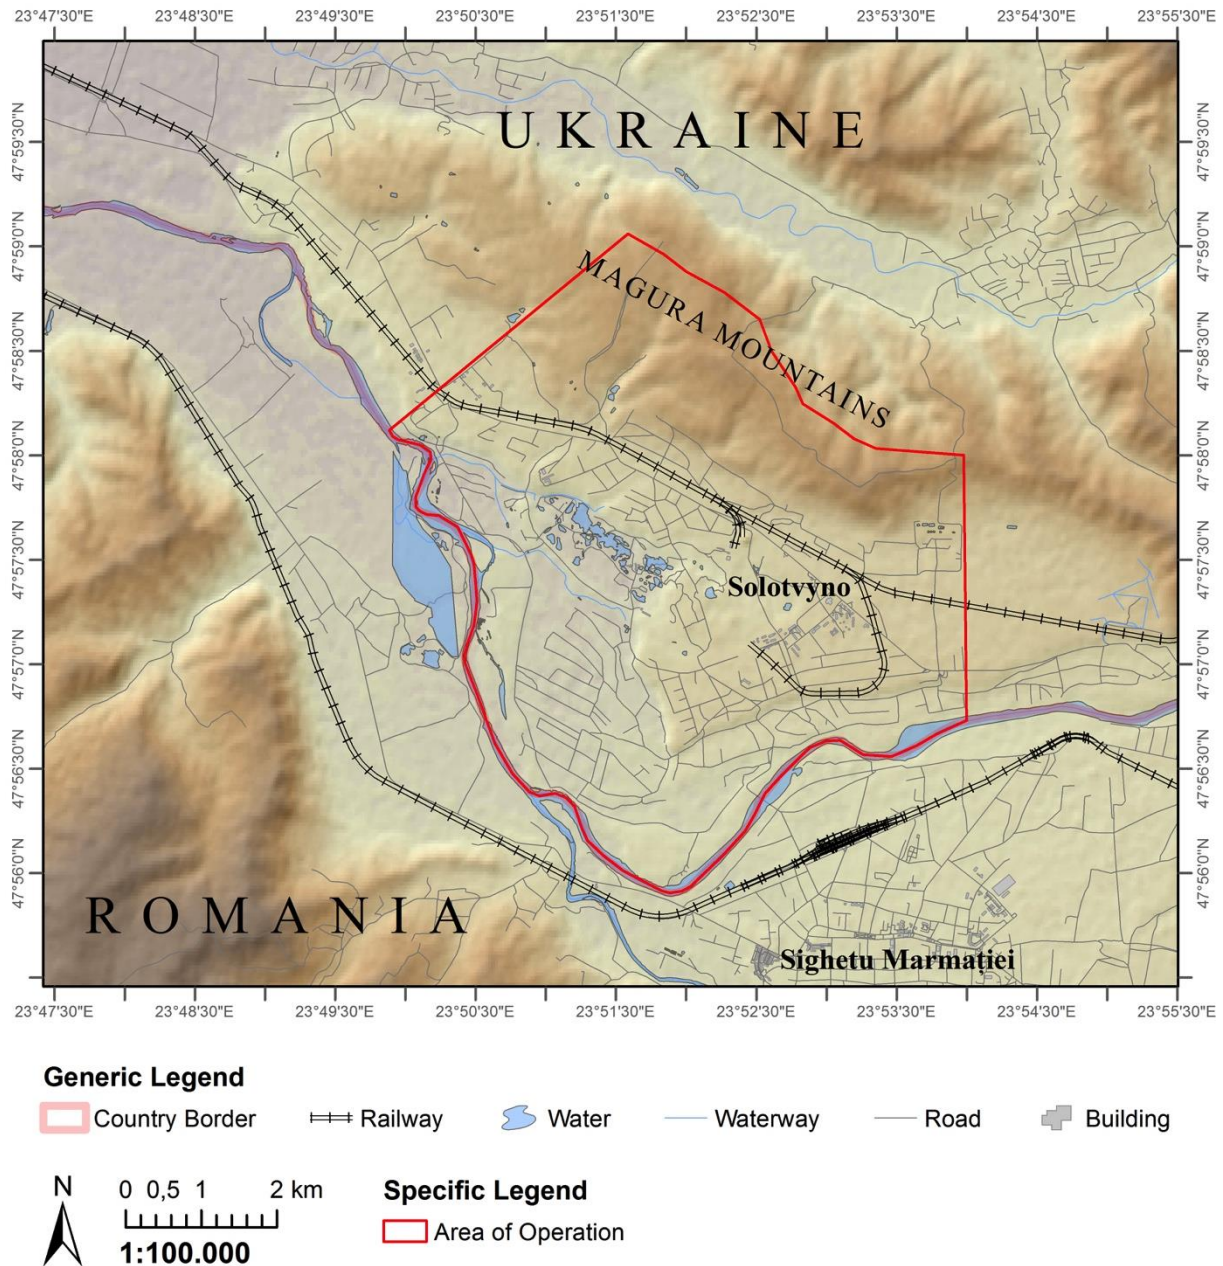
Figure 3.1.1: Assessment perimeter (red shape)

Following the report of the EUCPT scoping mission a perimeter was set up by the EUCPT for the risk assessment. *See Figure 3.1.1.*

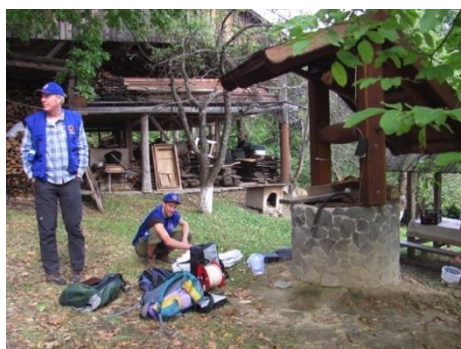
Figure 3.1.1.1: Water well measurements and sampling

At each well position, e.g. *Figure 3.1.1.1*, once permission to sample had been obtained, interviews were used to determine how often and who used the supply. In wells without pumps groundwater levels were determined using a graduated electrical dip meter with an alarm to indicate contact with water. A jug sample was used to undertake the physico-chemical analyses (steps 1-3) detailed above and a second sample was obtained for laboratory determinations.

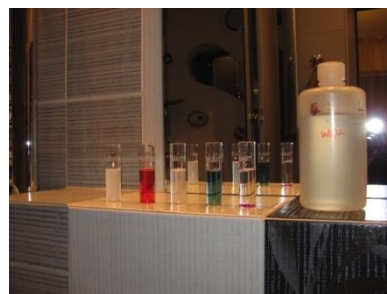
Figure 3.1.1.2: 6 samples (a-f)

1. The selected water samples were filtered using Whatman 25 mm GD/X sterile syringe filters. A separate filter was used for each water sample.
2. 10 ml water samples were prepared in accordance with the Palintest methodology. Dilutions were undertaken using deionized water.
3. The following tests were undertaken on each sample *See Figure 3.1.1.2*:
 - a) Alkalinity (Alkaphot) method Phot 2
 - b) Calcium hardness (Calcicol) method Phot 12
 - c) Chloride (Chloridol) method Phot 46, 51, 101 or 102, depending on dilution).
 - d) Potassium method Phot 30
 - e) Sulphate method Phot 32
 - f) Total hardness (Hardicol) method Phot 15

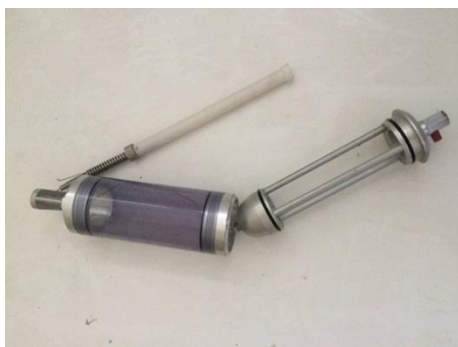
Figure 3.1.1.3

A bailer (See *Figure 3.1.1.3*) attached to a 200m cable was used for depth specific water sampling. The device was lowered to the desired sampling depth before a slider was activated which activated a mechanism to capture the water at that depth in the bailer. The water sample was then used, to first rinse a 330 ml sampling PET bottle two times, then filled to the top preventing air entrapment (used for chemical analyses). A second sample was taken in a 30 ml glass bottle (analysis of stable water isotopes, no rinsing needed).

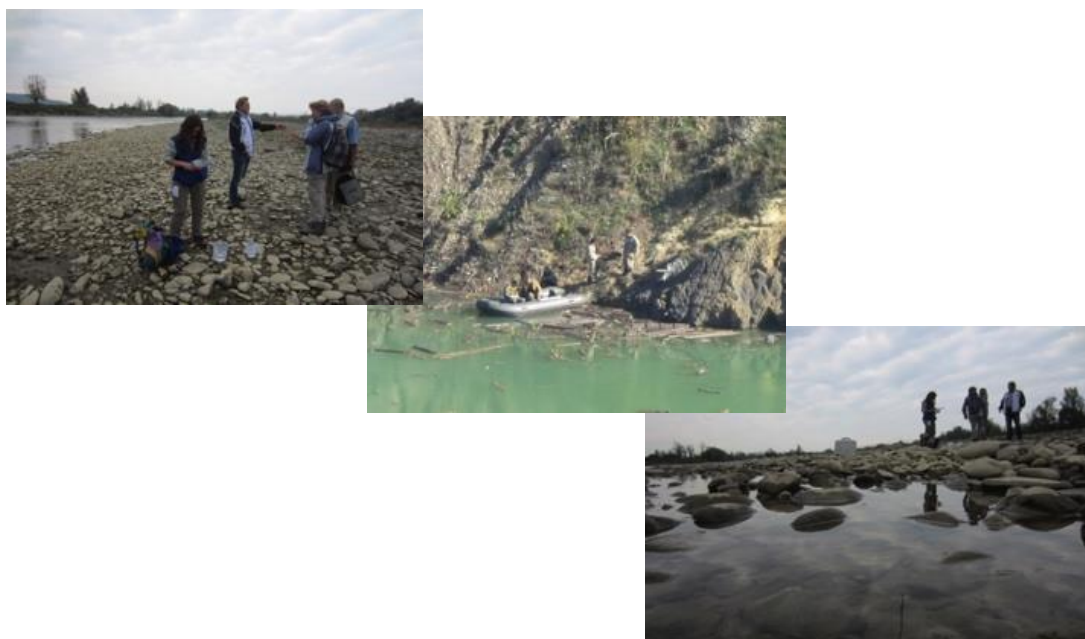
The bailer was additionally used in the mineshafts No 9 and No 8 to obtain samples for stable isotopes as well as chemistry. The conductivity meter WTW with the 50 m cable was further used to conduct depth specific profiles of electrolytic conductivity and temperature in Lake 18. It was also applied to measure the water depth at various locations by manually determining the point of resistance when the probe touches the ground (max. depth 50 m). Examples of the sampling activities are shown in *figure 3.1.1.4*.

Figure 3.1.1.4: Sampling of the Tisza River (left and right) and the Collapse of Mine 7

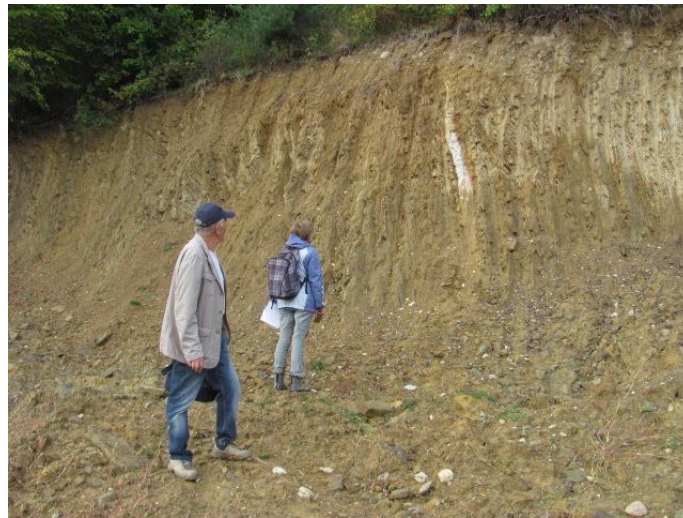
Figure 3.3.B.2: Weathered, deformed bedrock

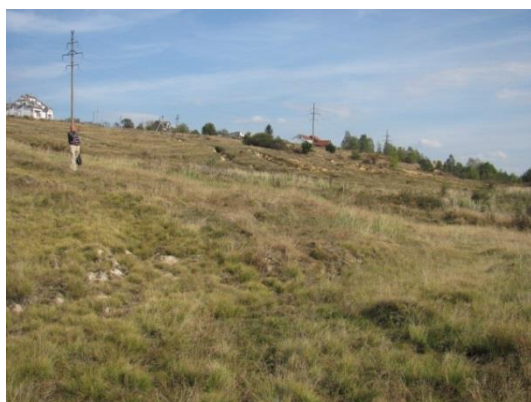
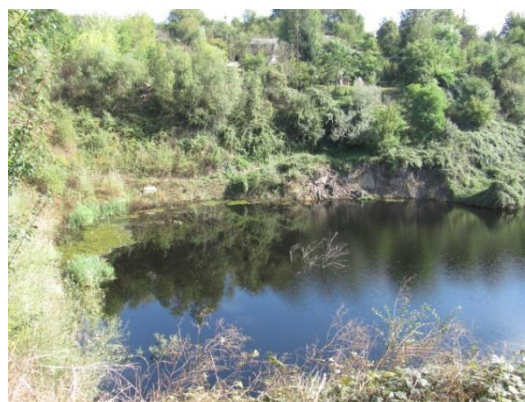
Another distinctive geomorphological feature that characterises the area is the development of landslides both within the sinkholes and collapse features (section 3.3.E) and on the steep slopes of the Magura Mountain where translational landslides develop as a consequence of crack propagation and piping breaching the loess and facilitating tension gap development (*Figure 3.3.D.2*).

Figure 3.3.D.2 and 3 Landslides on the Magura Mountain and in the Black Moor respectively.

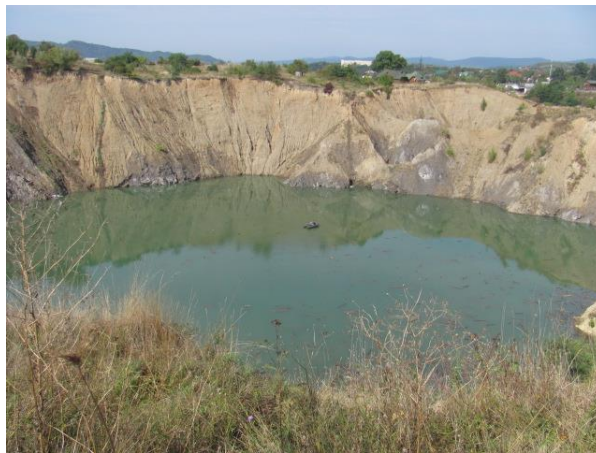
Clearly, the most significant geomorphological impact of human activity is the mining impact; which has resulted in: underground voids with varying degrees of saturation; focused leakage from supporting infrastructure, particularly the drainage channels; mounds of material remnant from phases of abandonment and collapse, and most significantly a series of collapse features where upward stoping of the mine workings has propagated to the surface, e.g. *Figure 3.3.E.1.*

Figure 3.3.E.1: Collapse subsidence above Mine No 7.

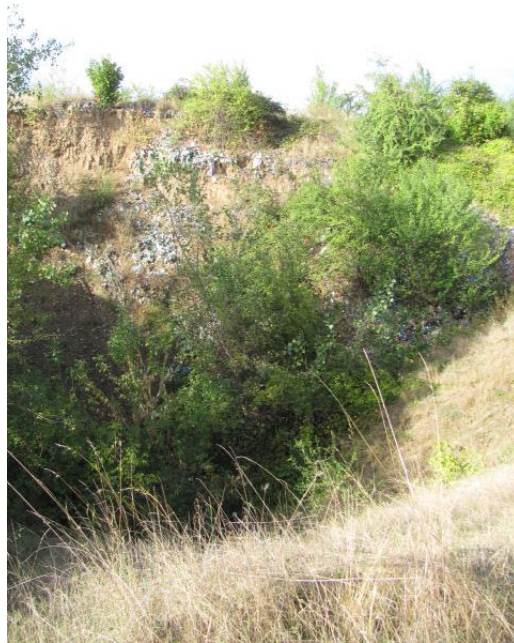
Another feature of the Anthropocene is the extensive use of the collapses and sinkholes for the unregulated disposal of waste, e.g. *Figure 3.3.E.2.*

Figure 3.3.E.2: Use of collapse features for waste disposal

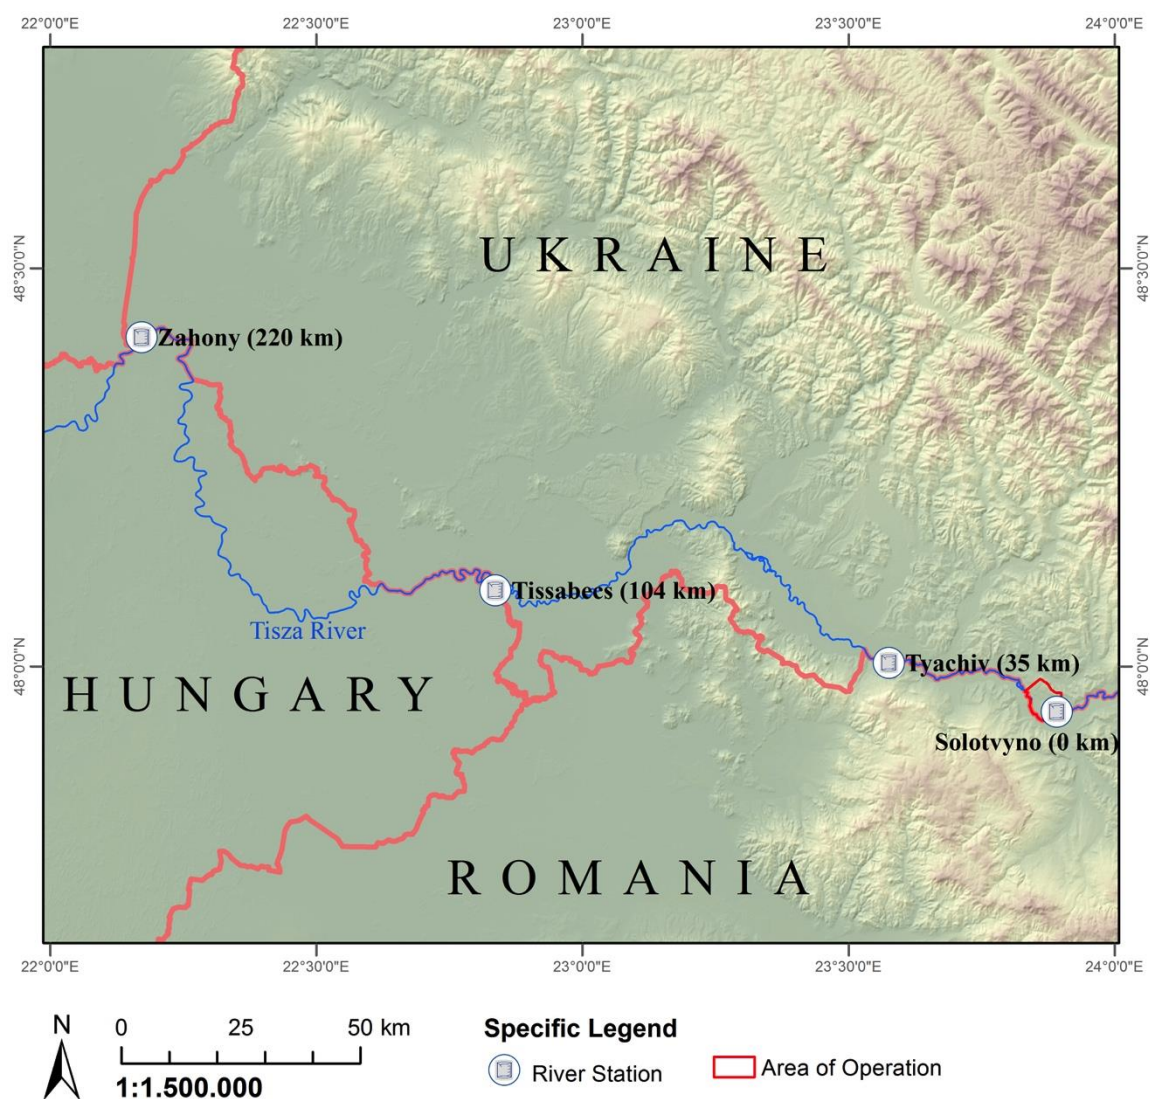
Figure 3.4.1: Tisza River course

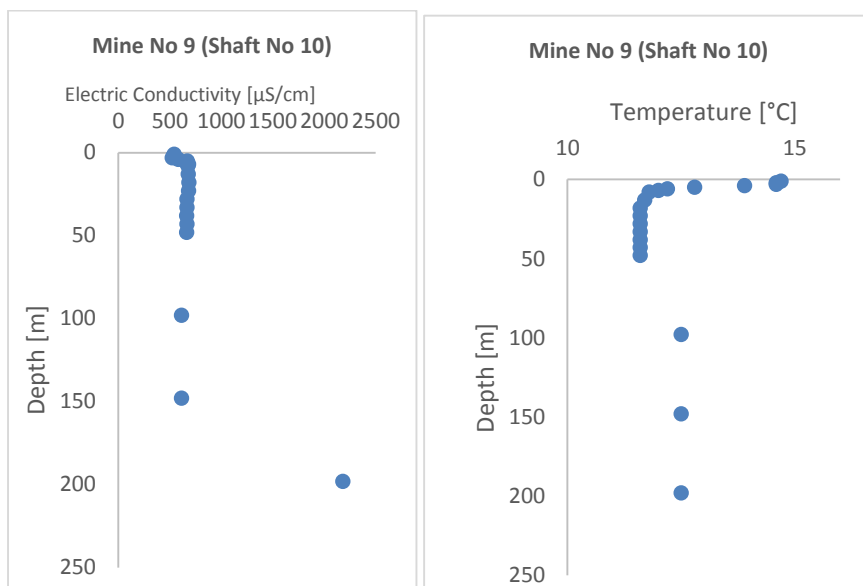
Shaft No 10, called “skip-shaft” by the local population, was used for material transportation. Its original depth is around 525 m, but only the last 30 m are believed to penetrate the salt dome according to correspondence with the mining staff. The water level was approximately 3 m below surface. *Figure 3.4.12* shows a depth profile of electrolytic conductivity, which indicates fresh water over the complete measurement range (up to 298 m below water level). Slight mineralization is indicated at a depth of 198 m; however, here pieces of iron from the shaft irons were found in the water, which was coloured red. This may not reflect the “natural” water composition, as the bailer hit the shaft construction several times. The temperature remained constant throughout. The three deepest measurements in *Figure 3.4.12* were achieved by taking a sample with the bailer. Due to the subsequent measurement of temperature after pulling the bailer up and sampling procedure, a temperature rise of around 1 °C may have occurred.

Figure 3.4.12: Electrolytic conductivity and temperature at shaft No 10 (skip shaft of mine No 9)

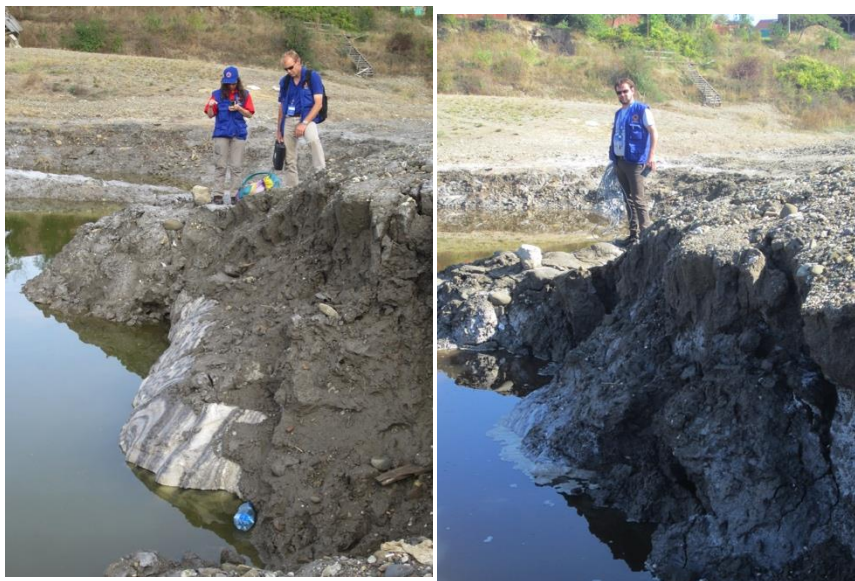
The largest lake in the area is Lake 18 (mistakenly declared “Lake Kunigunda” in several sources including google earth), situated in the NW of the Solotvyno mining area. Smaller lakes, which generally show higher salinity values, are situated SE of Lake 18, from which Lake Kunigunda was visited. Here, salt outcrops could be observed. During the time of the mission, the salt outcrop was significantly altered, presumably by anthropogenic mining by the local population on a very small scale, to sell it to tourists. See Figure 3.4.16.

Figure 3.4.16: Same perspective of the salt outcrops at Lake Kunigunda at the beginning (left) and end (right) of the mission

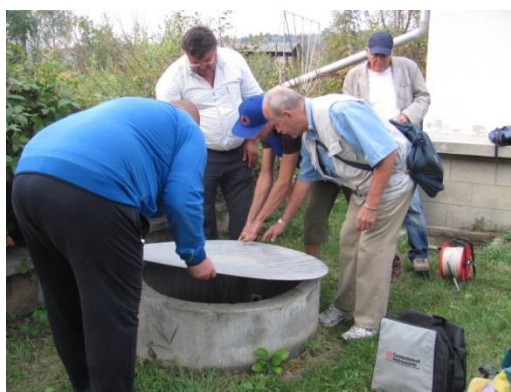
Figure 3.5.4 Well sampled at EUCPT008.

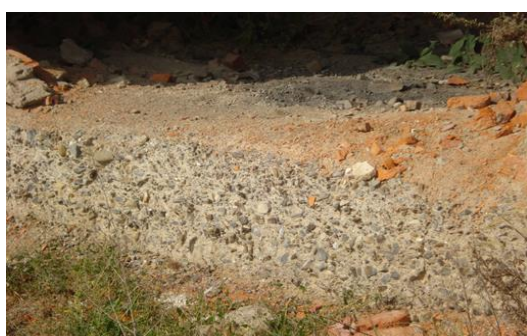
The concrete platforms are generally not reinforced, or poorly reinforced and the concrete is filled with pebbles instead of gravel (Figures 3.6.1 & 3.6.2).

Figure 3.6.1: Unreinforced concrete platform

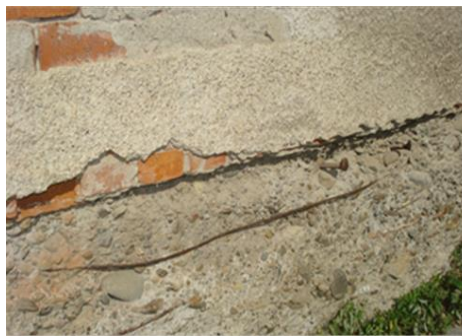
Figure 3.6.2: Poorly reinforced concrete platform

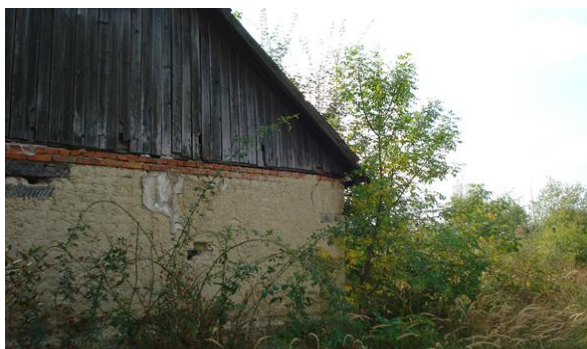
The masonry consists of handmade compressed earth blocks, cement blocks and in some cases wood, rock, bricks or adobes, mainly without connecting material, plaster and isolation and without concrete zoning (“chainage”) (Figure 3.6.3).

Figure 3.6.3: Masonry of wood, bricks and adobes without “chainage”

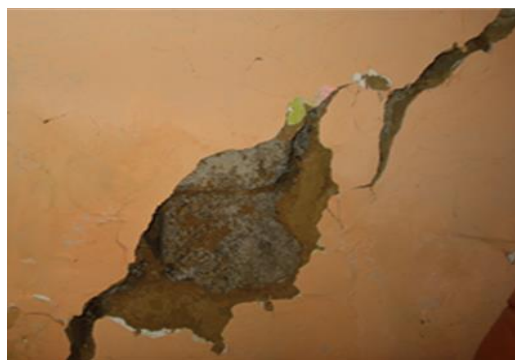
The majority of the plastering mortars, where ever they are applied, consist of compressed earth with straws covered by paint (Figure 3.6.4).

Figure 3.6.4: Plaster of compressed earth with straws

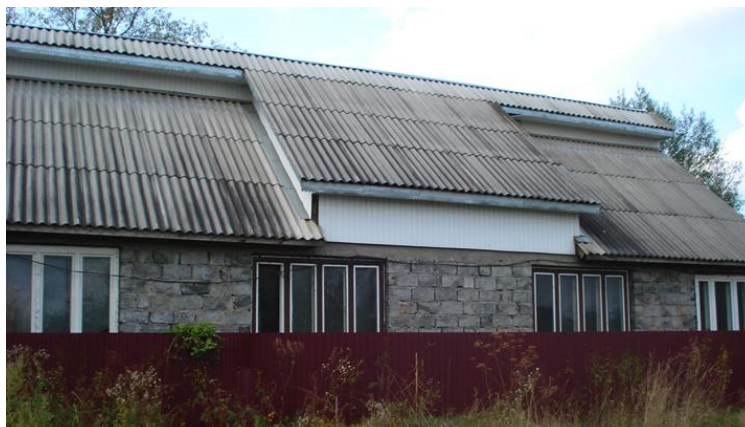
The roofs are mostly covered by asbestos slates (Figure 3.6.5) and in some rare cases by metallic roof plates.

Figure 3.6.5: Roof covered by asbestos slates

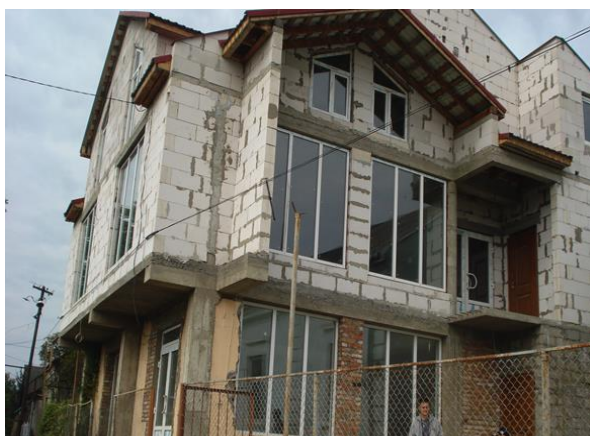
In very few cases there are some reinforced concrete elements but even then they are not operating as they should since there are very few beams, no ties with the few existing columns and the concrete slabs bear directly on the masonry frames (Figure 3.6.6). The concrete slabs, where and when they exist, are very thin (~10 cm-15 cm) and rarely reinforced.

Figure 3.6.6: Building with mixed material masonry, some concrete elements and thin slabs

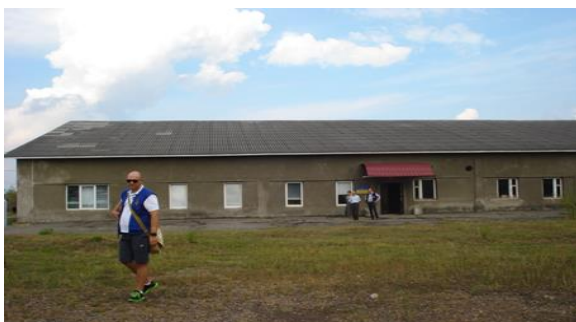
The Central Mine Administrative building is a 2 storey mixed material masonry construction (rock, bricks, wood, handmade compressed earth blocks) built in two phases (Figures 3.6.8, 3.6.9 and 3.6.10). The second part is not in use.

Figure 3.6.8: Central Mine Administrative building (part in use)

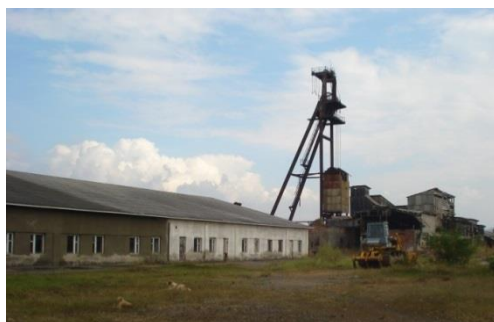
Figure 3.6.9: Central Mine Administrative building. The white part is not in use

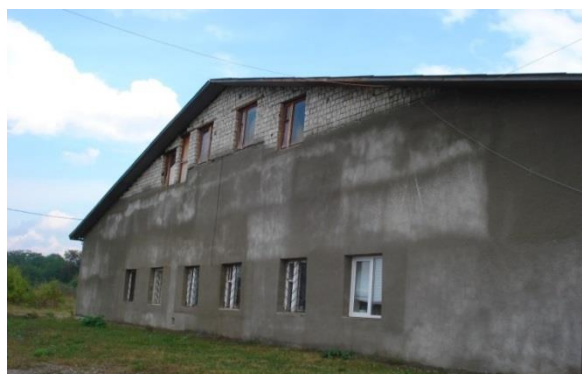
Figure 3.6.10: Central Mine Administrative building (east side)

It is obvious that the building has never been restored or maintained throughout the years. All the other buildings are partially collapsed and are not in use for several years.

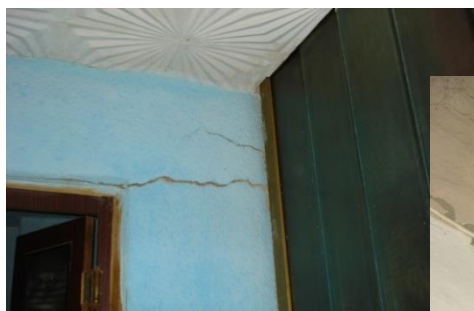
Figure 3.6.11: Through cracking on the masonry infill

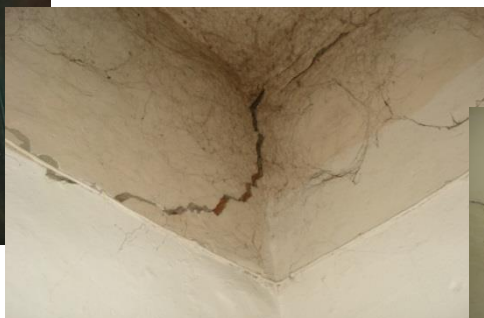
Figure 3.6.12: Extended cracking on the masonry

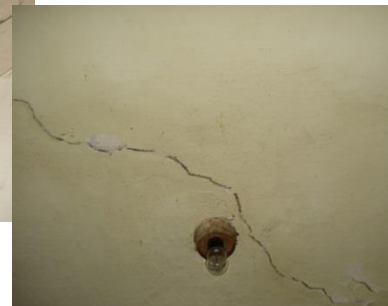
Figure 3.6.13: Extended cracking on the roof

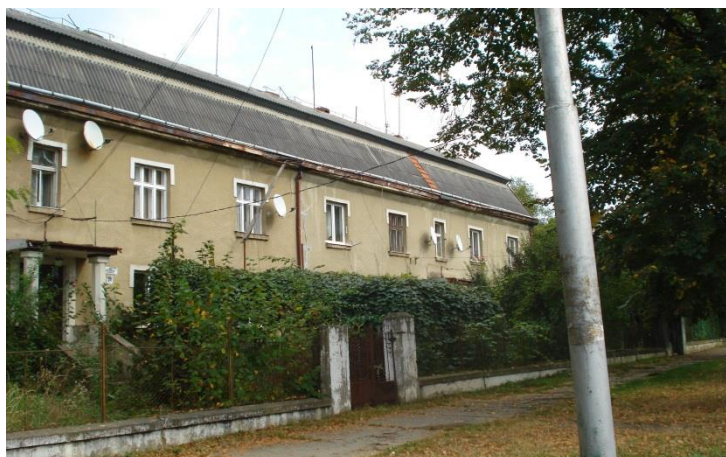
The 2 storey apartment building at the S-SE side of the Mine entrance was built late 1920`s - early 1930`s, has three entrances, a basement and 8 apartments. The building is a masonry (brick) construction with concrete elements based on a hollow poorly reinforced concrete platform (basement) (Figure 3.6.14).

Figure 3.6.14: Outward aspect of the apartment building

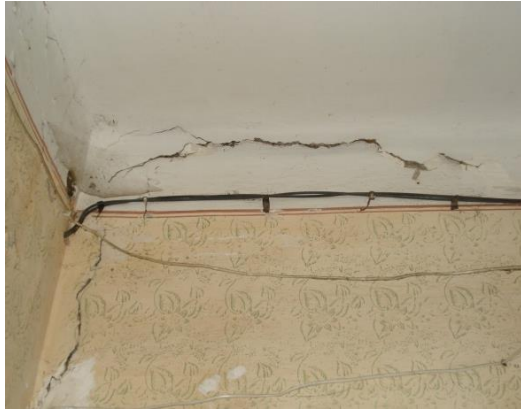
The basement is based on bare ground and the oxidation of the few existing reinforcement of the roof is obvious.

Figure 3.6.15: Internal masonry crackings

The behavior of the soil as a viscous liquid will cause further damages to the houses/buildings/structures such as sinking, partial or total collapse and extended through masonry cracking (Figure 3.6.15).

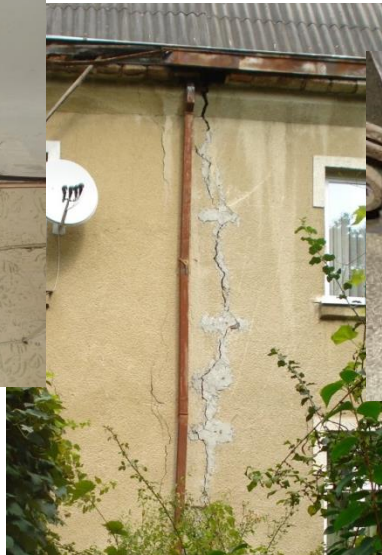
Figure 3.6.16: Vertical through cracking

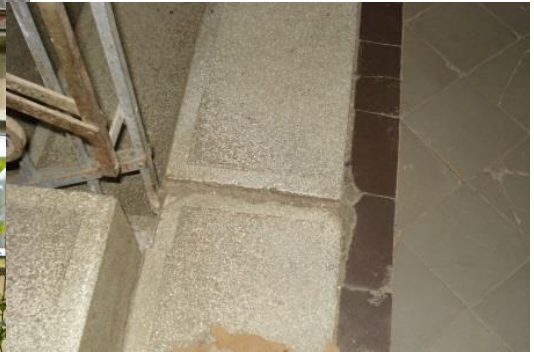
Figure 3.6.17: One of the three staircases

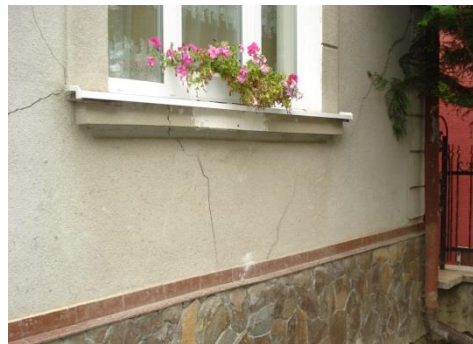
Extended external masonry crackings were also observed at two houses on the other side of the street (Figure 3.6.18). The houses in the surrounding area present no obvious damages.

Figure 3.6.18: Masonry crackings

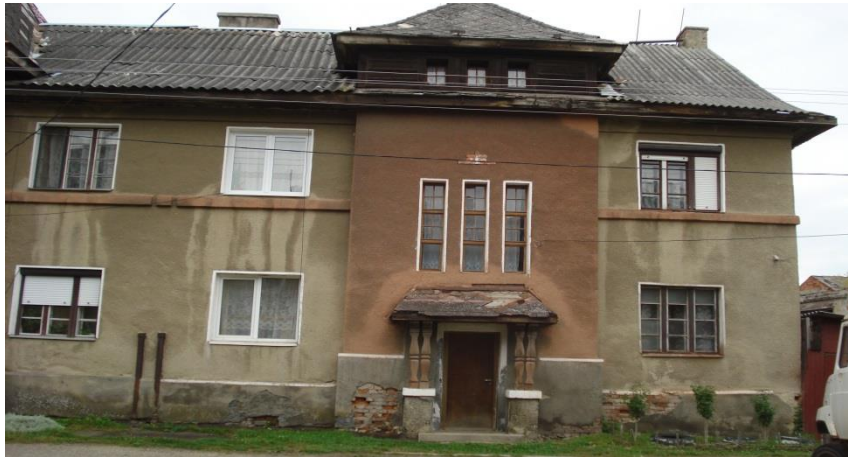
The 2 storey masonry apartment building (built ~1950 – 1955), is located at the South of Mine No 8 and presents no exterior damages. The owner denied the entrance to the inspection team so the inspection was not completed (Figure 3.6.19).

Figure 3.6.19: Outward aspect of the apartment building near M8

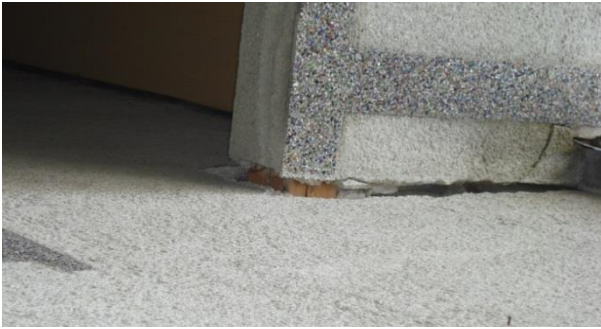
The street is located at the N-NE side of the Mine No7 collapse. There are 50 constructions/houses in Solena Street. Most of the houses were built in the 1970`s and 1980`s. Extended through crackings and splits have been observed on the masonry of the houses. There are also gaps (~5cm) in the junctions between the external walls and the pavements and deviation from vertical (tilts) (Figures 3.6.20, 3.6.21, 3.6.22, 3.6.23 and 3.6.24). One of the two houses at no 48 is partially collapsed (Figure 3.6.25, **Point 4c**). An extensive soil subsidence (~20cm) is present at the entire length of the backyards of the houses in the south side of the street.

Figure 3.6.20: Masonry wall separated from the base

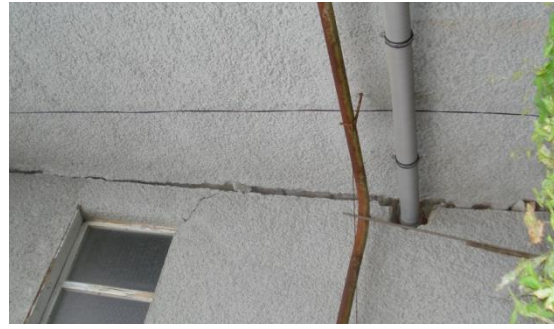
Figure 3.6.21: Masonry wall separated from the roof

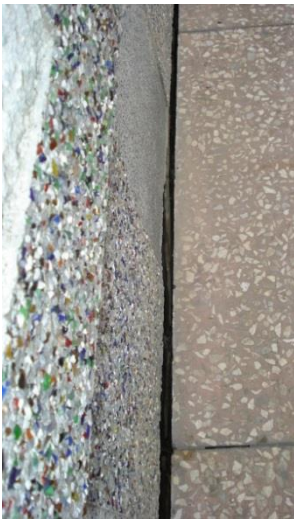
Figure 3.6.22: Gap
between external wall and
pavement

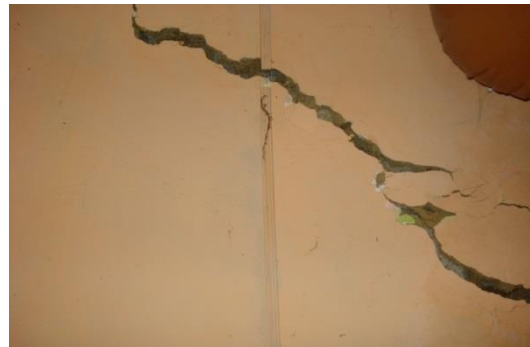
Figure 3.6.23: Extended through crackings

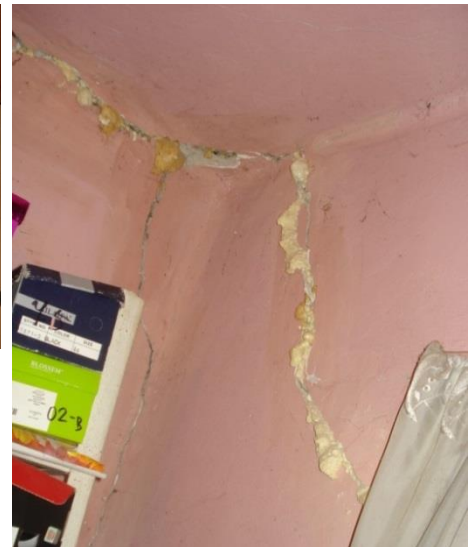
Figure 3.6.24: Extended through crackings

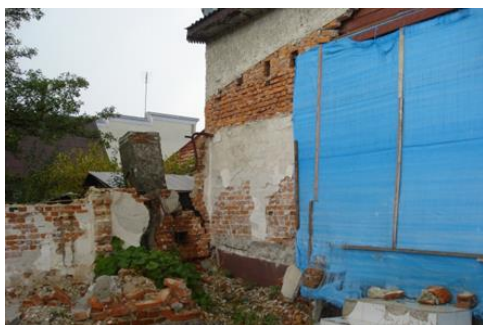
According to the residents of the street, the first noticeable damages appeared 10 to 12 years ago and are gradually progressing. 10% of the houses are recent constructions (2009-2014) and they do not present any obvious damages.

Figure 3.6.25: Partially collapsed house

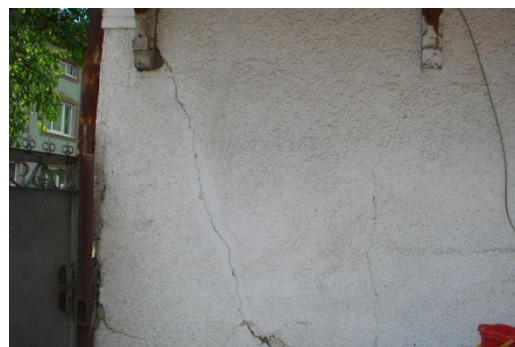
Figure 3.6.26: Through crackings at a house in the north
side of Solena Street

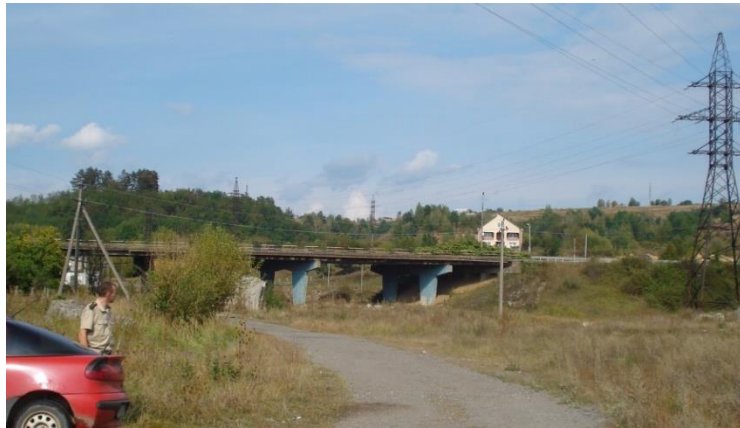
The Bridge is considered stable and the slight damages observed are due to age, weather conditions and lack of proper maintenance.

Figure 3.6.27: Highway Bridge

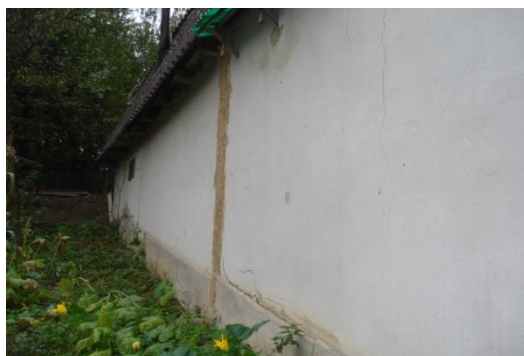
Figure 3.6.29: Vertical through cracking

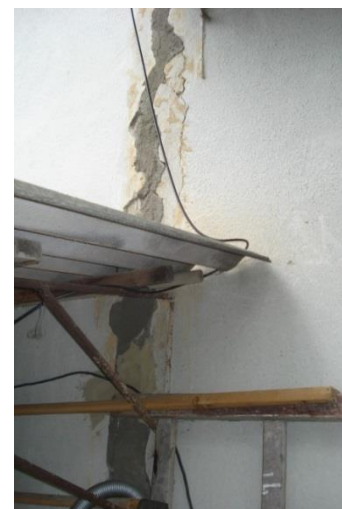
Figure 3.6.30: Vertical through cracking

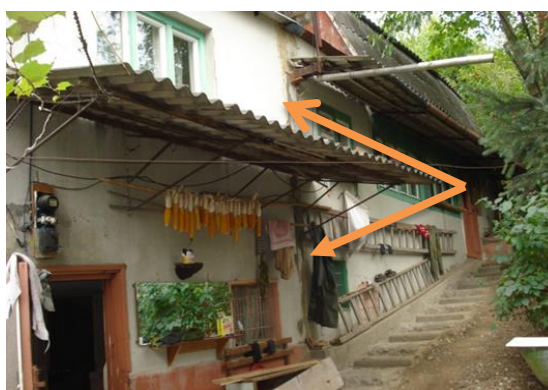
Figure 3.6.31: Vertical through cracking at the back side of the house

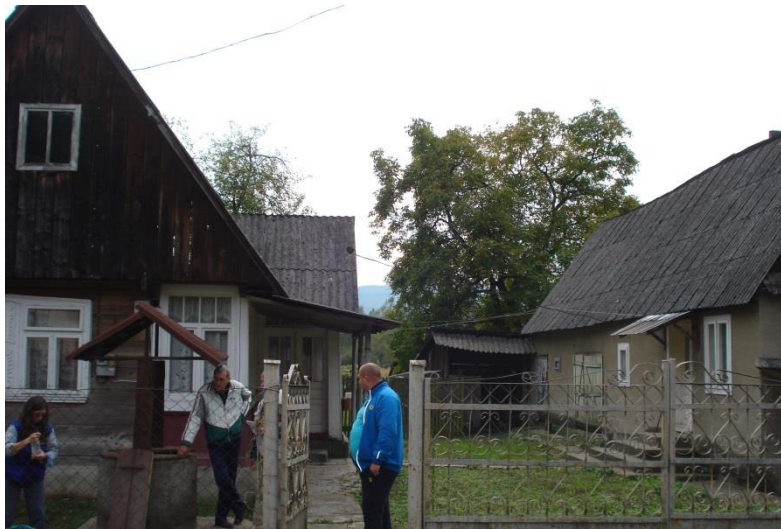
Although there are no damages on the masonry, both houses have extended crackings on the bases (Figures 3.6.32, 3.6.33 and 3.6.34).

Figure 3.6.32: Outward aspect of the two houses on the No 13 of Zarechnaya Street

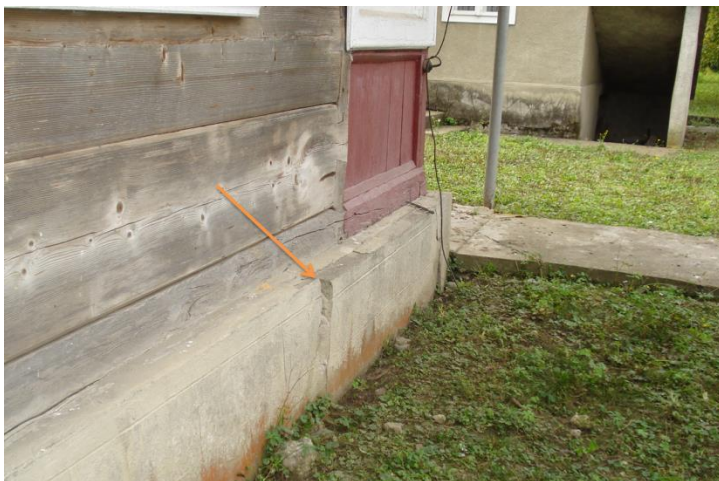
Figure 3.6.33: Cracking and obvious movement on the base of the wooden house

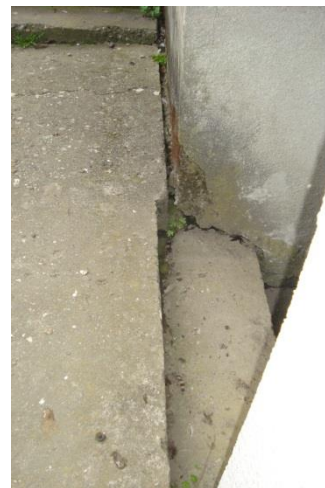
Figure 3.6.34: Gap between the basement staircase and the external wall

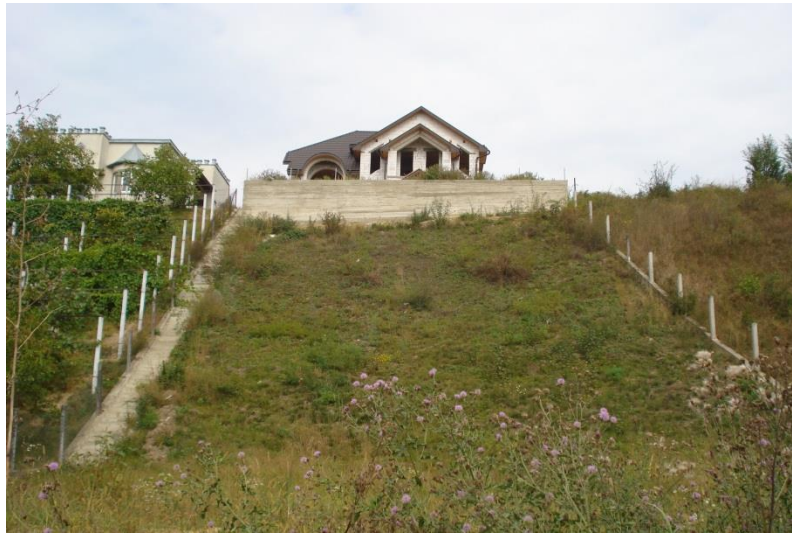
- The observed damages on the constructions certify a ground movement on the N-NE, SE-S area around the mines.
- Although there are considerable steep inclines in the affected area, only one retaining wall (**Point 8**) was observed in the slope area near Tisza River (residential area) (Figure 3.6.35).

Figure 3.6.35: Retaining wall in the residential area near Tisza River

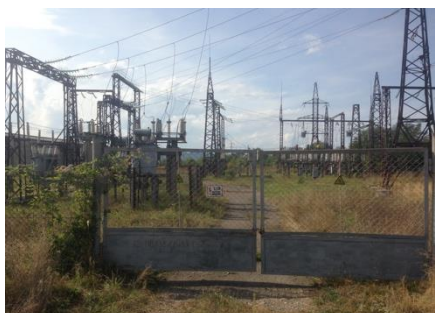
Figure 3.6.38: electric power substation

Next to shaft 10 in the northern part of the mining area, the mining company built an electric power substation [EPS] for the mining works. A 110 kV power line enters and leaves the substation. The power line supplies Tatsiv or beyond and leads to the Rakhiv district. In the substation transformer 1 lowers the voltage to 35kV and 6kV. The 35kV feeds another power line to Rakhiv and transformer 2. This transforms 35kV to 6kV. The 6KV feeds the municipality of Solotvyno. Since the mining works stopped the substation feeds 3560 houses and 300 businesses in Solotvyno. The substation subsided between 5 and 10 years ago. Some power lines are visually more tense than others. The local electricity company (REM) has no plans for relocate the station. It is not clear who is the owner of the substation as REM and the mining company are co-owners without a clear division. If the substation trips, this has most effects on Solotvyno. In the district of Rakhiv a second system can provide backup electric power to the district. The same applies to failure of the power line (interview with head and employee REM on 28/29-9-2016).

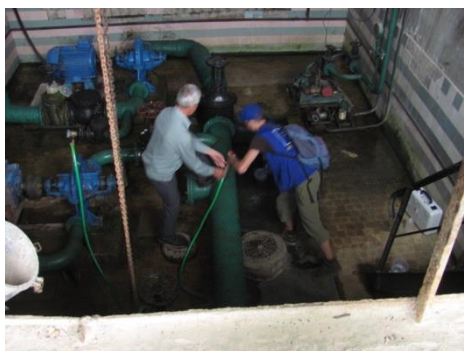
Figure 3.6.39: pumps on floodplain Tisza

The drinking water is pumped from a well, which is 13 meters deep [DWW] in the floodplain of the Tisza. It is transported to the drinking water facility (reservoirs) [DWF] south of the town. It is located on the edge of the mining area relatively close to the new craters of the collapses of Mine No 8. When the craters formed, the main drinking water pipes supplying the town were broken. This also happened when the Black Moor sinkhole formed. The municipality of Solotvyno is responsible for water supply and built a new sub-surface system further away from the crater. The pipe, which broke when the sinkhole in the Black Moor appeared, was not replaced. Water supply to the households in Solotvyno is restricted to a few hours each day. Several years ago the well in the floodplain of the Tisza was sampled and

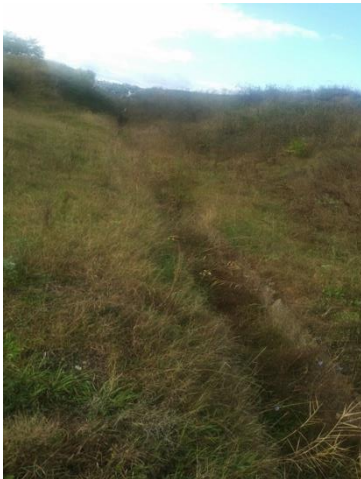
Two surface water creeks were present previously (Glod and Isvor). These surface water creeks (channelling systems) have also lost their function due to the development of sinkholes. The creeks are fed by the precipitation falling in the Magura Mountain, collecting surface water from precipitation in the Solotvyno mine area. As a consequence, an artificial water channel was developed to direct the water away from the Glod Creek into the starting point of the North ‘stolna’(see Figure 3.7.2 WAY IN point). Due to the subsidence, the channel is not functioning today (found to be dry), as it is leading uphill. Additionally, the intake (WAY IN in Figure 1) of North ‘stolna’ is filled with communal waste as shown in Figure 3.7.3.

Figure 3.7.2 Artificial channel guiding water from the Glod Creek

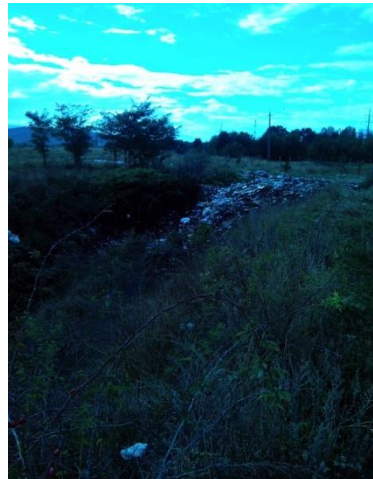
Figure 3.7.3 The Stolna and the communal waste infill.

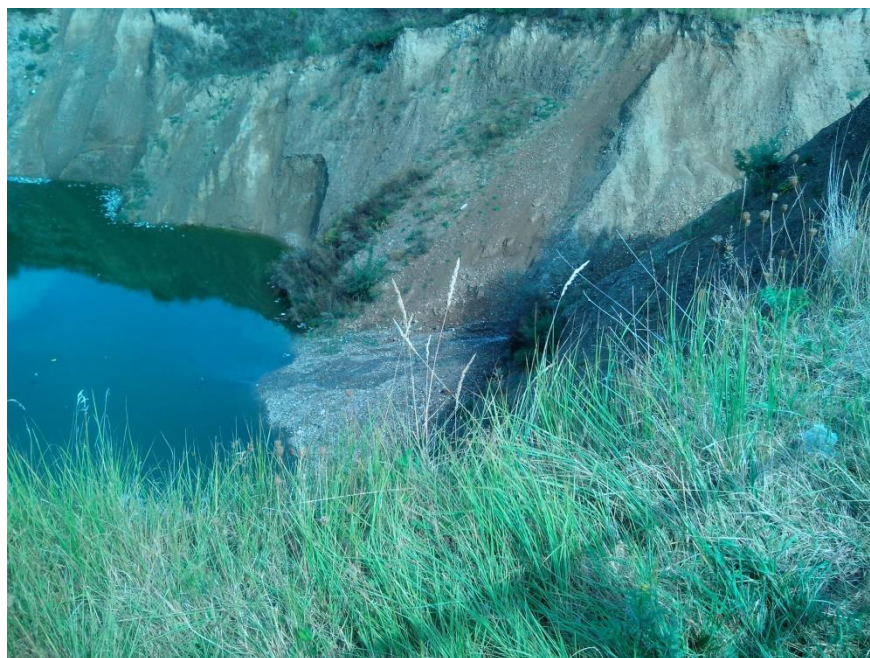
Figure 3.7.4

It is remarkable that not only the artificial channels designed to lead surface water away and the ‘stolna’ system for shallow groundwater control were destroyed and collapsed (partly or totally) by ground movement resulting from the collapse crater, but the other line facilities (drinking and wastewater networks, gas pipelines, railroads, electricity network) have been affected. As an example there is wastewater flowing directly into the Mine No 8 subsidence (Figure 3.7.4)

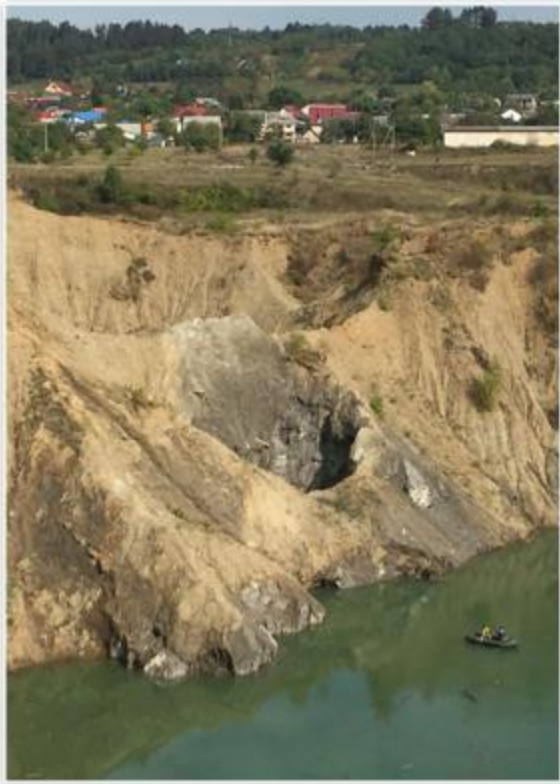
Figure: Crater of Mine No 7 during water sampling by the Ukrainian Mountain Rescue Team. The hole in front of the boat is the old mining shaft No 7.
